INTERSTATE SERVICE PLAZA RETROFITS AS A BMP DEMONSTRATION PROJECT

Marianne Walch, Randall Cole and Wendy Polasko
Delaware Department of Transportation, Stormwater Quality Program
P.O. Box 778, Dover, DE 19903

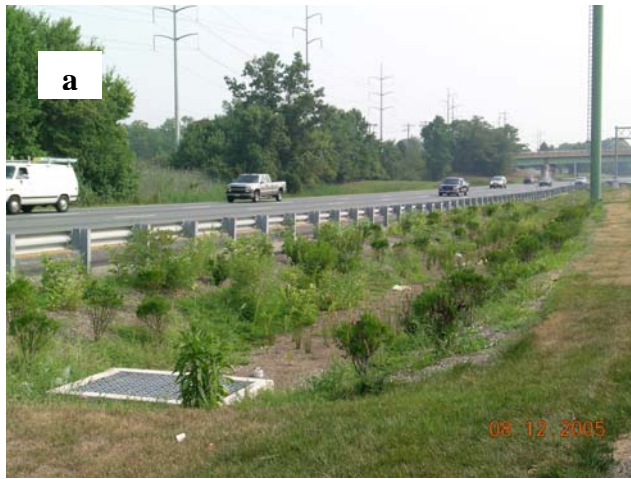
Figure 1. Photographs of BMP retrofits installed for evaluation at the I-95 service plaza in Newark, DE: (a) bioretention cell in swale that drains southbound highway and service lanes; (b) view into vault of StormFilter unit; (c) Delaware sand filter installed in drainage of service station; (d) view into BaySaver manhole; (e) HydroKleen unit mounted in storm drain inlet; (f) HydroKleen unit modified to collect effluent samples.

- A bioretention cell to replace concrete swales located between the southbound highway lanes and the plaza (Figure 1(a)).
- A StormFilter[®] unit installed south of the Exxon service station (Figure 1(b)).
- A sand filter installed north of the Exxon service station at the east end of the service plaza (Figure 1(c)).
- A BaySaver[®] device installed in the drainage area of the food service area of the plaza (Figure 1(d)).
